CALIBRES NO. 01		CS08-19-C-001-E	A
		Made by: pelrom	Date: 15.04.04

Circuit Calibre 1383

FIXING THE CIRCUIT

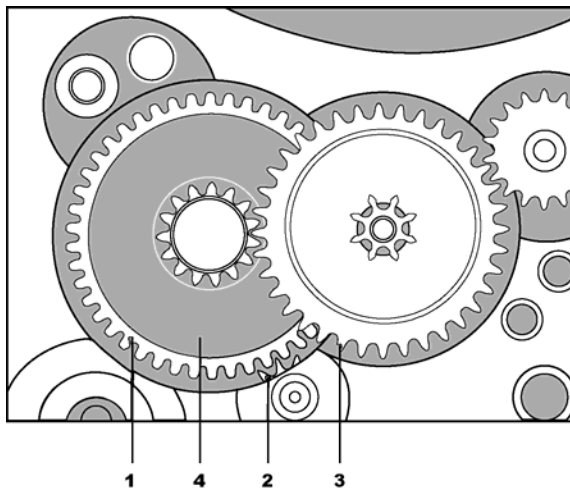
1. Risk of a lack of synchronisation between the centre wheel (1) and the third wheel pinion (2)
2. Watch stopping or losing time
3. Lower working limit exceeds 1.15 V
4. The hands touch the crystal or the dial

1. **Risk of a lack of synchronisation between the centre wheel (1) and the third wheel pinion (2).**
 - Insert a disk 1379/497 (4) (thickness 0.40mm) between the centre wheel (1) and the minute wheel (3).
 - Lower working limit.

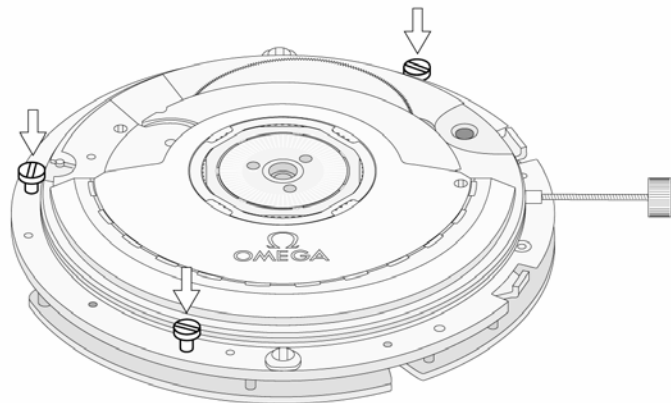
Figure 1

The assembling screws which attach the basic movement to the chronograph module are fragile.

- The new screws, made of stainless steel, have a better resistance than the old screws, which were made of steel for profile turning.
- The screw has been improved by adding a groove at the top of the thread (see figure 2).
- The design has been improved by an additional support washer placed between the chronograph module and the basic movement (see figure 2 and 3).

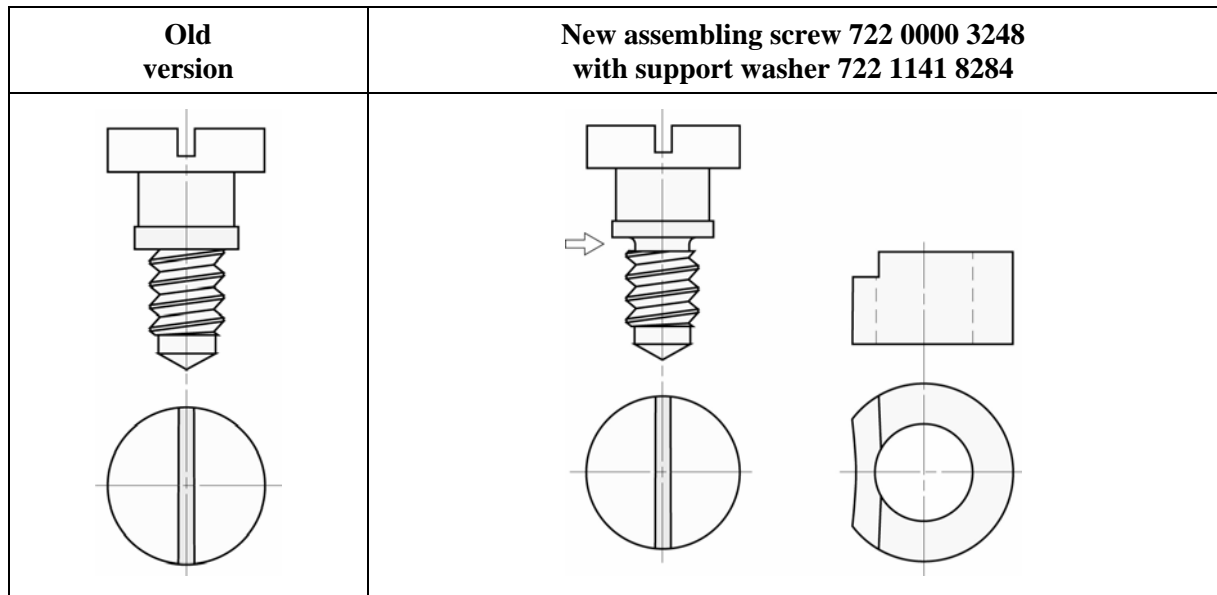
Figure 2

The new assembling screw can be easily identified by the groove at the top of the thread (see figure 2).

Replacement of the old assembling screws by the new version (with the support washer). For all assembling screw orders, the new screws will be delivered with the support washer.

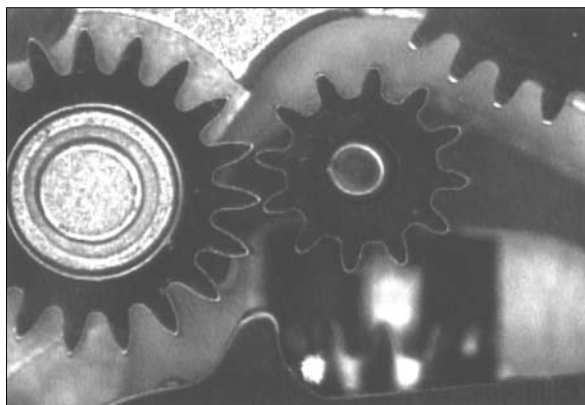
The teeth of *setting wheel 1128 31.100* are too short and provoke a butting of the gear *setting wheel - intermediate setting wheel 1120 31.101* (See picture below). As a result the upper part of *hour wheel 31.046*, which is in direct contact with the *intermediate setting wheel 1120 31.101* (via *intermediate setting wheel 1128 31.101* and an *additional wheel* riveted on *mechanism platform 1128 16.010.06*), may be momentarily blocked. Consequently, the watch owner recognises that the hour hand has lost one or more hours. The minute and second hands are, however, not affected by this failure.

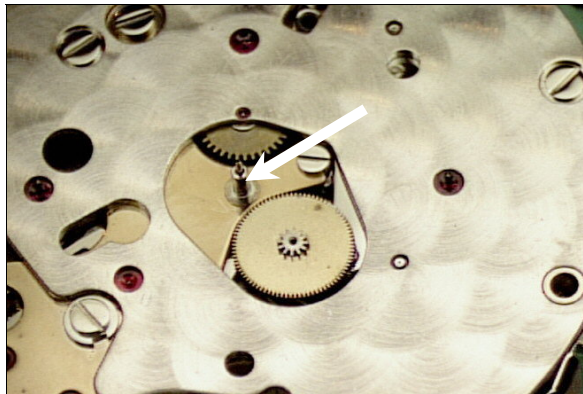
The movements have been analysed, and rusty sections between the centre tube of the chronograph module (see picture below) and the *free cannon pinion* ref. 3220 31.081P have been discovered.

The parts of the movements with above mentioned rusty sections have to be carefully cleaned, and the old steel *free cannon pinion* must be replaced by the new version in copper-beryllium.

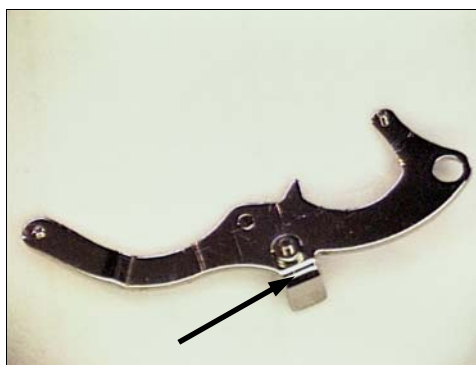
If the return to zero pusher is pressed strongly while the chronograph is running, the *hammer operating lever* may bend slightly (see arrow below). As a result, the return to zero function no longer works properly.

On movements with the above-mentioned problem, the *hammer operating lever* must be replaced with the new version with modified shape. The new *operating lever* is available from Omega, the reference remains unchanged (ref. 722 3303 55.047).

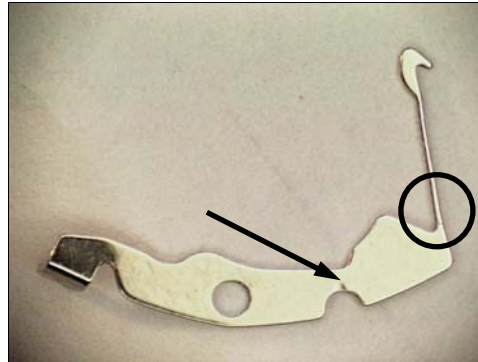
Due to a deficiency in the material, the *column wheel operating lever* may bend at its weakest point (see arrow below) when the start/ stop pusher is pressed.

On movements with the above-mentioned problem, the *column wheel operating lever* must be replaced with the new modified version. The new *column wheel operating lever* is available from Omega, the reference remains unchanged (ref. 722 3303 55.040).

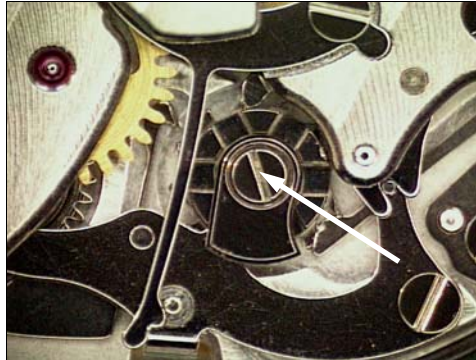
The start/stop function no longer works. The basic movement may also stop working.

The head of the *hammer-lever banking screw*, which also holds the column wheel in place, (see arrow) has broken. As a result, the start/stop push function does not work and the basic movement may be stopped because the screw head or the hammer limitation bridge (ref. 722 3303 10.615) are blocking the movement. The screw head may break, because the wrong screws have been used on a few pieces in production.

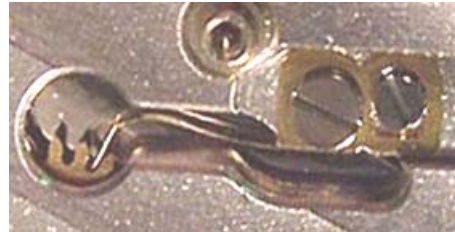
There has been a noticeable increase in the number of watches for repair due to broken *minute counter jumpers* on calibres 3301, 3303 and 3313. The *minute counter jumper* breaks at the bent end (see arrow on picture left). After the break, if the chronograph is reset, the jumper bends completely (see picture on the right).

A new *minute counter jumper* has been designed.
