CALIBRES NO. 01		CS08-19-C-001-E	A
		Made by: pelrom	Date: 15.04.04

Circuit Calibre 1383

FIXING THE CIRCUIT

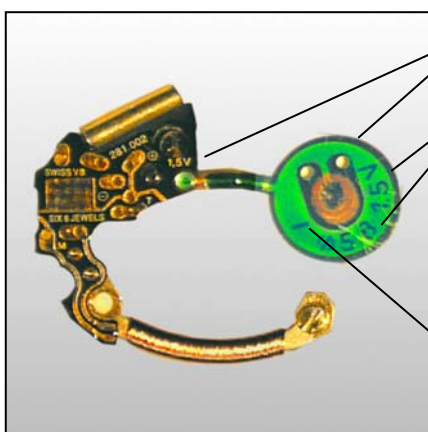
New version

Battery voltage: 1.5 V

Imprint
Ø 5.8 / 1.5 Volts
on the battery contact

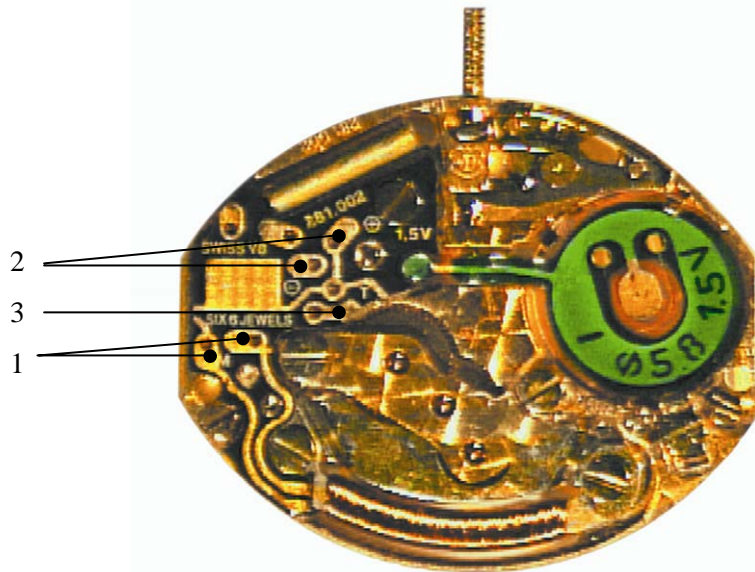
3. ELECTRICAL TESTS

Position	Measurement	Test
1	2.10 - 2.50 K Ω	Resistance of coil
2	0.3 μ A	Consumption of movement
3	1.1 Volts	Lower working limit

For lower working limit, connect point T to negative printed circuit conductor.

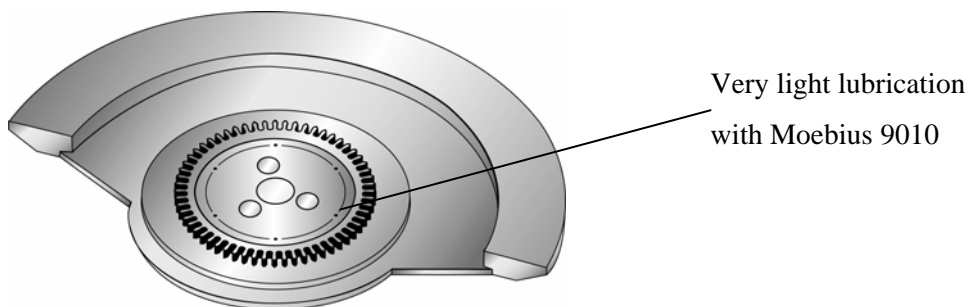
- 2.1 Test the wind on a Cyclotest 1 rpm for 24 hours and check the power reserve: It should be at least 44 hours.
- 2.2 Check the quality of the reversing wheel 1110/1464 and the clearance of the ball bearing of the rotor 1110/1479, which should be checked by air projection, using small bellows.

The ball bearing 1110/1479 is available from stock already lubricated.

If the ball bearing has to be cleaned, oil lightly with Moebius 9010 or dip it in a greasy solution (benzine + oil Moebius 9010 in a proportion of 5/1000).

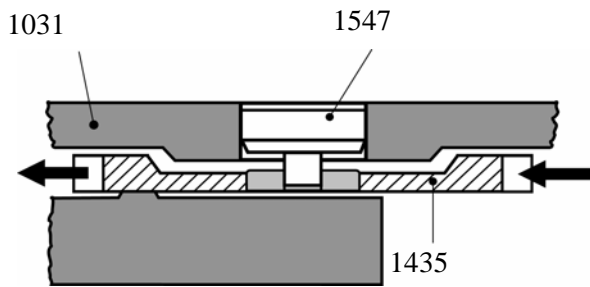
2.3 New intermediate reduction wheel 1110/1435.

- The jewel 4199 is replaced with bushing 1547, which is driven in until level with the bridge.

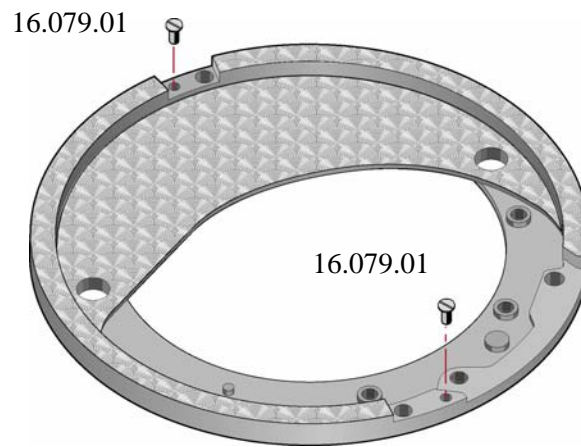
- The jumper screws for the jumping hours (no. 56.093.01) have been modified to prevent the heads from breaking. The reference has not changed. If the movement is disassembled, the two screws must always be replaced by the modified screws.

- The screws for the jumping hours mechanism plate (no. 16.079.01) could not be modified either and must therefore also be screwed in very carefully.

- The old jumper screws for the jumping hours (no. 56.093.01) may be used for the driver screw for the jumping hours finger (no. 36.104.01), given that they are identical. The new modified screws have the reference no. 56.093.01.

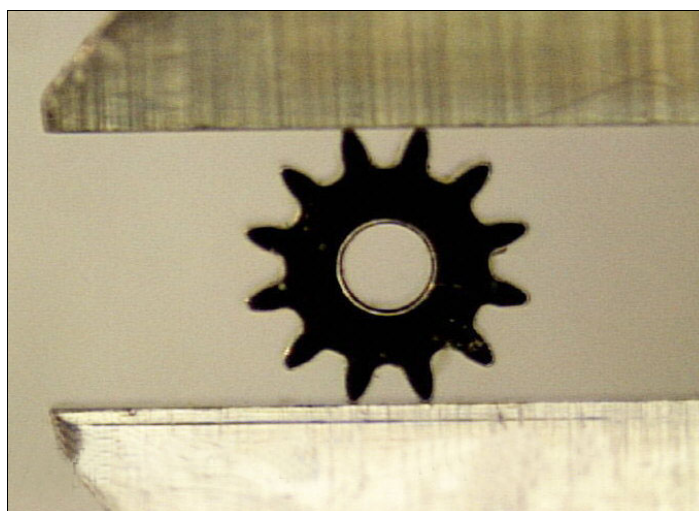
The teeth of *setting wheel 1128 31.100* are too short and provoke a butting of the gear *setting wheel - intermediate setting wheel 1120 31.101* (See picture below). As a result the upper part of *hour wheel 31.046*, which is in direct contact with the *intermediate setting wheel 1120 31.101* (via *intermediate setting wheel 1128 31.101* and an *additional wheel* riveted on *mechanism platform 1128 16.010.06*), may be momentarily blocked. Consequently, the watch owner recognises that the hour hand has lost one or more hours. The minute and second hands are, however, not affected by this failure.

The new *setting wheel* has the same reference number as the old one (ref. 1128 31.100). The two can, however, be distinguished by measuring the difference of diameter with a sliding caliper.

- The new *setting wheel* has a diameter of 1.54 mm (measure over 4 teeth with a sliding caliper as shown below).
- The old *setting wheel* has a diameter of 1.50 mm.

All stocked *setting wheels* ref. 1128 31.100 in the old version have to be destroyed and replaced by the new version (with the same reference).

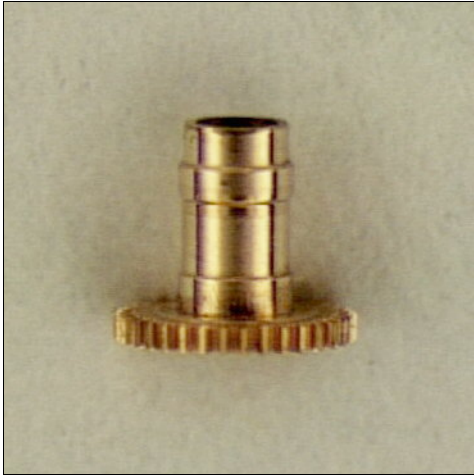
New (yellow)

The new *free cannon pinion* in copper-beryllium alloy (see picture below left), can easily be distinguished from the old *free cannon pinion* in steel (picture below right) by the difference in colour.

The parts of the movements with above mentioned rusty sections have to be carefully cleaned, and the old steel *free cannon pinion* must be replaced by the new version in copper-beryllium.

The reference of the new *free cannon pinion* remains unchanged (3220 31.081P). All stocked *free cannon pinions* of the old version in steel must be destroyed and replaced by the new version.

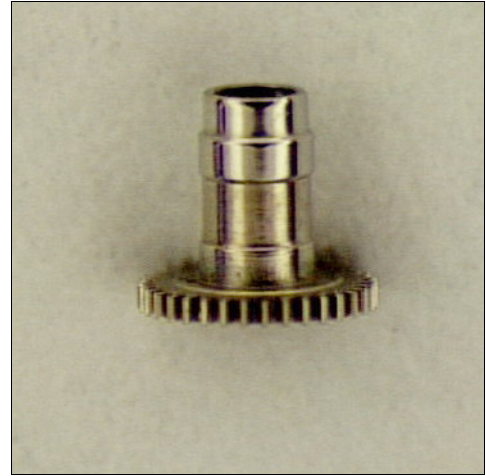
Old (white)

The movements have been analysed, and rusty sections between the centre tube of the chronograph module (see picture below) and the *free cannon pinion* ref. 3220 31.081P have been discovered.

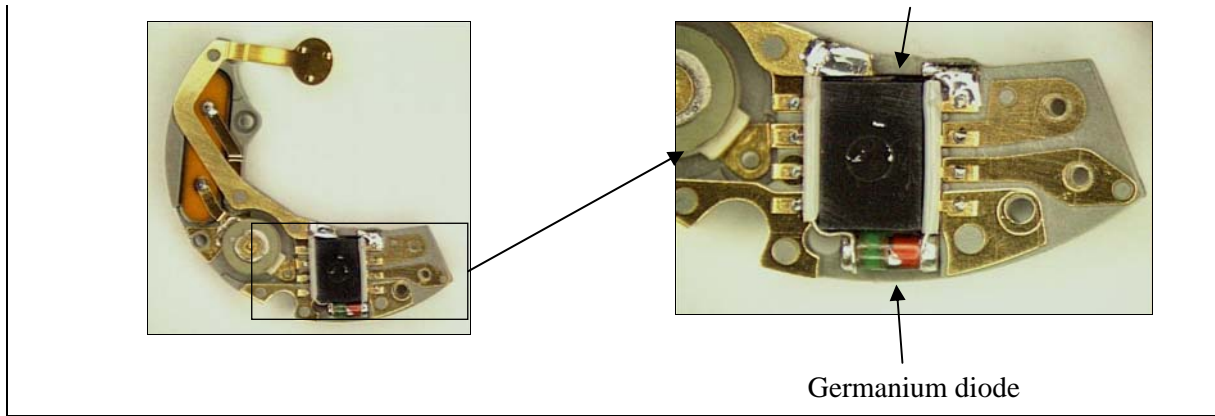
Separate conductive track

Modified module for 1.55 volts (silver oxide battery)

If a watch with calibre 1310 is sent in for a battery change and it does not yet have the modified module, the complete watch must be sent to OMEGA Customer Service in Switzerland. These watches will then undergo a complete maintenance service and be fitted with the modified module.

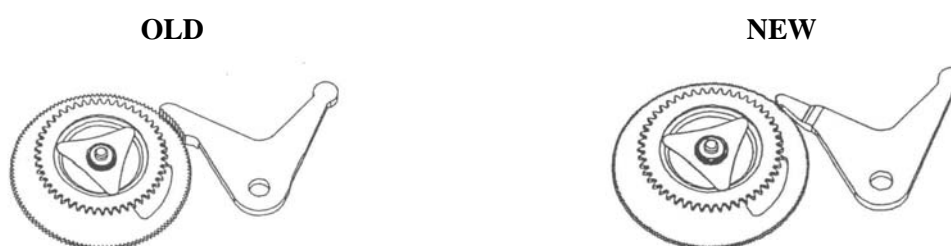
To solve the problem, both parts involved have been redesigned. The new *hour counting wheel* has 189 teeth (Old version 126) and the new *hour counter lock* has one tooth in metal alloy Durnico (Old version 9 teeth in synthetic material Delerin). **On watches with the above-mentioned problem, both parts must be exchanged with the new version.**
